# HISTORIC STRUCTURES REPORT

# MECKLENBURG TOBACCO

## WAREHOUSE

North Princess St.  
Shepherdstown, West Virginia

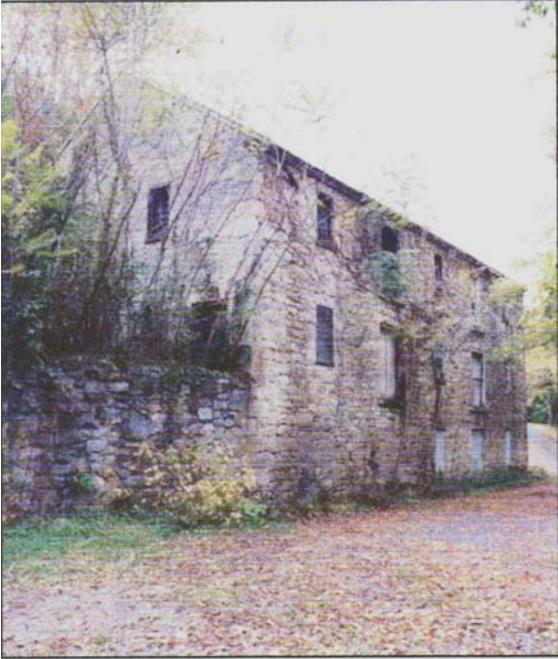
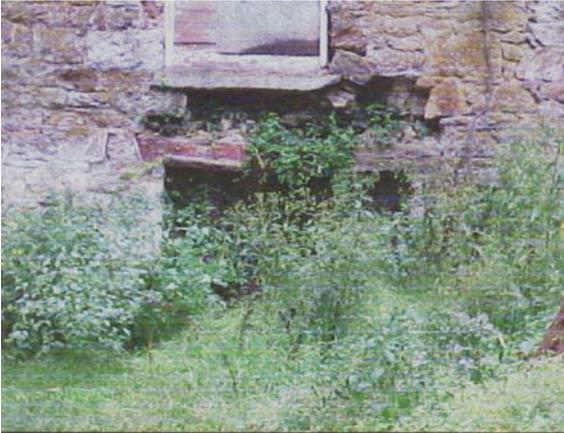
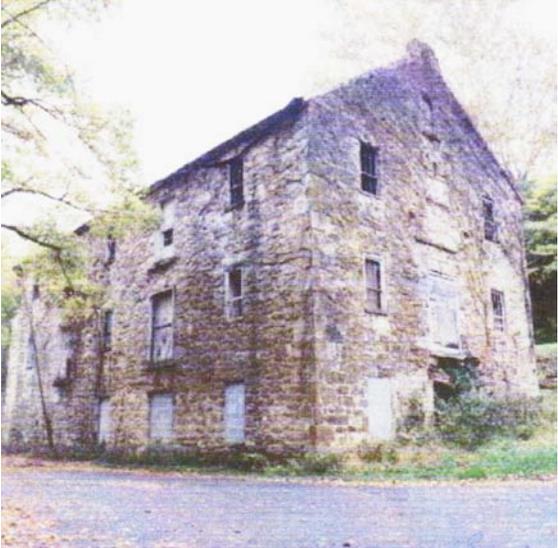
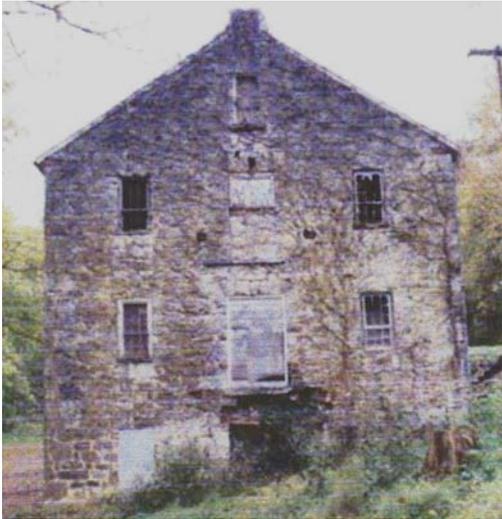
**Exhibit 3**

Condition of building prior to stabilization
